BELZONA® 1000 SERIES PRODUCTS RE-SEAT WEAR PLATES

Cement Plant
UK

The base plate of the Bradley Pulverizer had worn unevenly making it difficult to effectively reinstall new wear plates

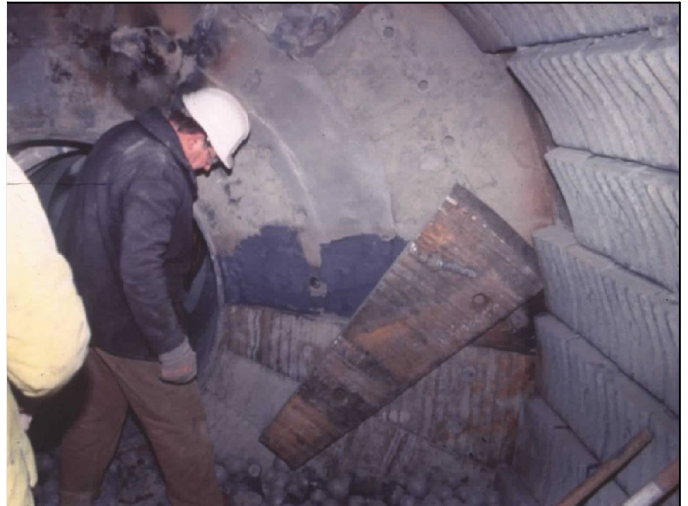
1. Belzona® 1121 Super XL Metal has been applied to all the worn areas, while a release agent has been applied to the underside of the new wear plates to ensure that they are easily removed when required.
2. Installation in progress.
3. Completed application.
