BELZONA® SEALS LEAKING TRANSFORMER FLANGES

ELECTRICAL UTILITY
Vancouver Island, BC.

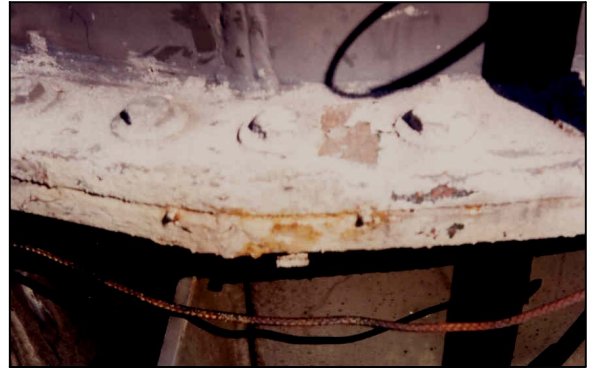
Oil was leaking out between the flanges.

1. View of oil covered flange
2. Flanges degreased and blasted to provide a good rough surface profile.
3. Application in progress with bolts being sealed first.
4. Completed application
