BELZONA® SEALS TRANSFORMER BUSS BOX

ELECTRICAL UTILITY COMPANY
Vernon, BC

August 2000

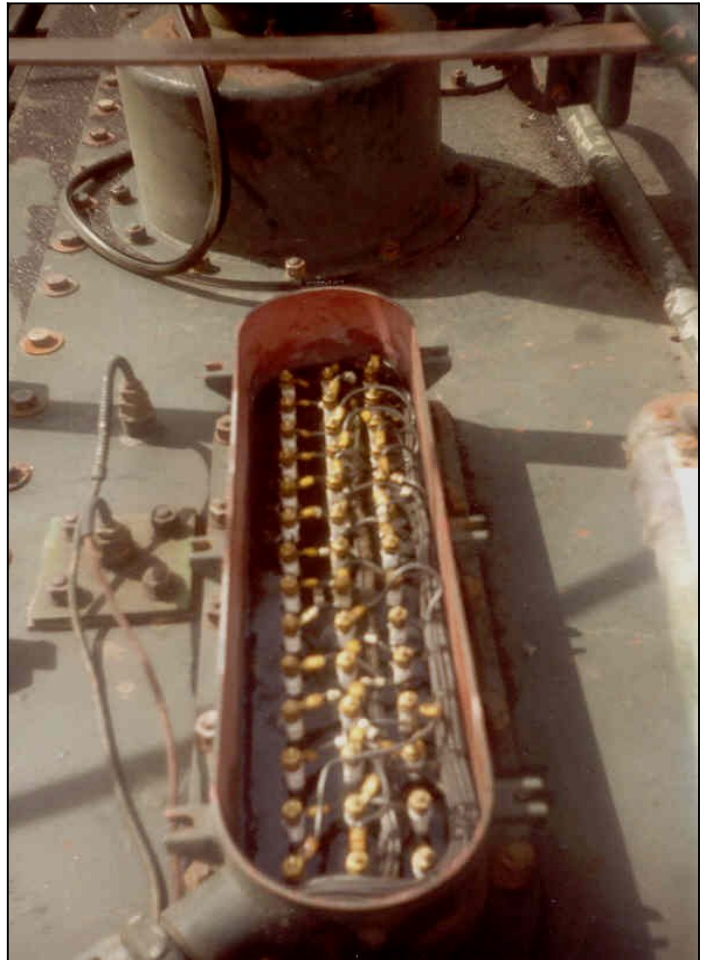
1. View of box after grit blasting
2. Belzona® 2221 MP Fluid Elastomer poured into the electrical box sealing
around all connection points.
