BELZONA® REBUILDS AND PROTECTS TURBINE RUNNER

Pulp & Paper Operation
Powell River, BC

May 2001

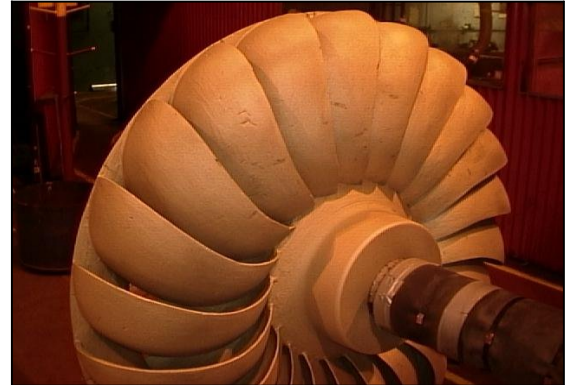
1. Turbine runner after initial grit blasting.
2. Leading edges of vanes rebuilt with Belzona® 1311 Ceramic R Metal.
3. Application of 1st coat of Belzona® 1341 Supermetalgilde in progress.
4. Completed application of 2nd coat of Belzona® 1341 Supermetalgilde
