BELZONA® REPAIRS LEAKING TRANSFORMER

Sawmill
Canoe, BC.

July 2005

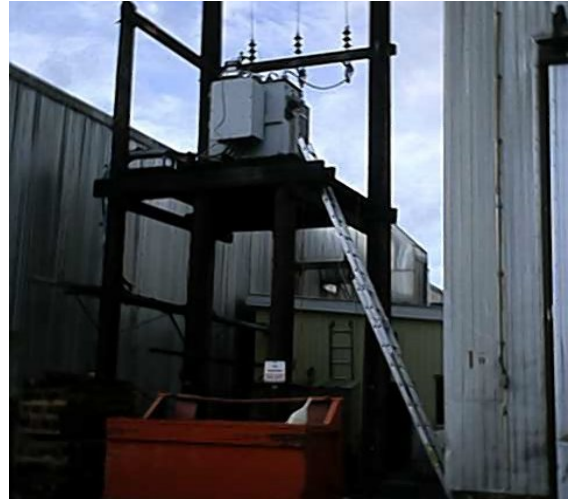
The cooling fins of the transformer had been damaged. Previous repairs lasted only a shortwhile

1. View of leaking transformer.
2. Surface preparation completed.
3. After initially sealing the hole with Belzona® 1221 Super E Metal area received a final overcoating layer of Belzona® 1111 Super Metal.
