BELZONA® SEALS SF₆ LEAKS AT HYDROELECTRIC POWER STATION

Power Generating Dam
Mica Creek, BC

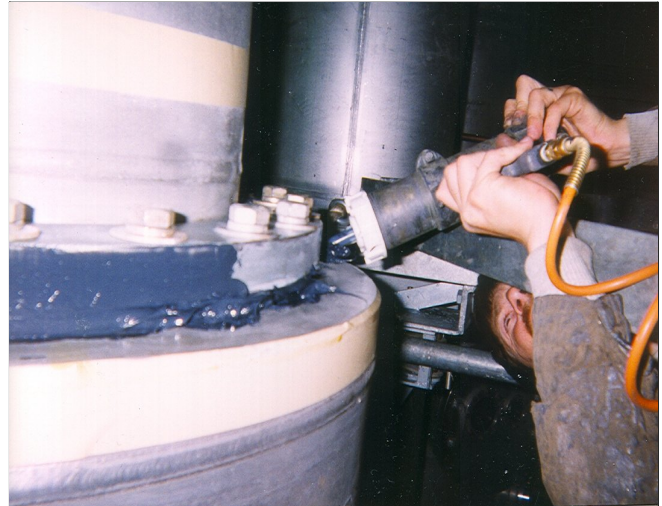
1. Belzona® 2211 was injected into the gap between the 2 flanges.
2. Application shown in #1 completed.
3. Another flange sealed.
