BELZONA® 2000 SERIES PRODUCTS SEAL GAS LEAK

Power Supply Company

June 1998

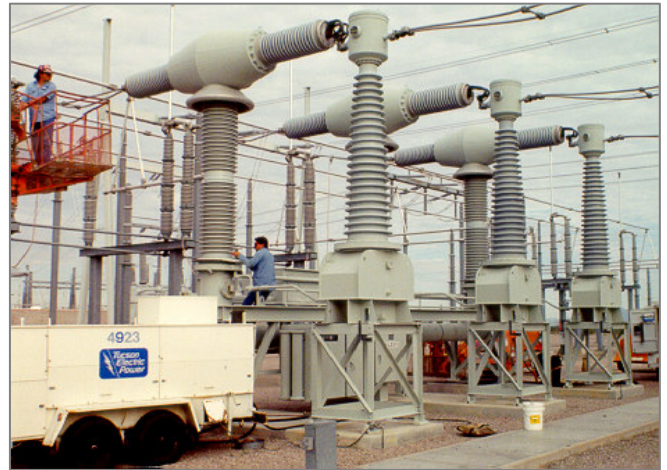
SF6 Gas was leaking through the porcelain bushing saels .

1. View of sub station
2. Preparation and repair under way.
3. Completed repair

Belzona® 2211 MP Hi-Build Elastomer

Application carried out in accordance with a modified version of Belzona® Know-How Leaflet VPF-11
