BELZONA® REBUILDS TUBE SHEETS SUFFERING FROM BI-METALLIC CORROSION

CUSTOMER
PULP MILL
Kamloops, BC.

August 1998

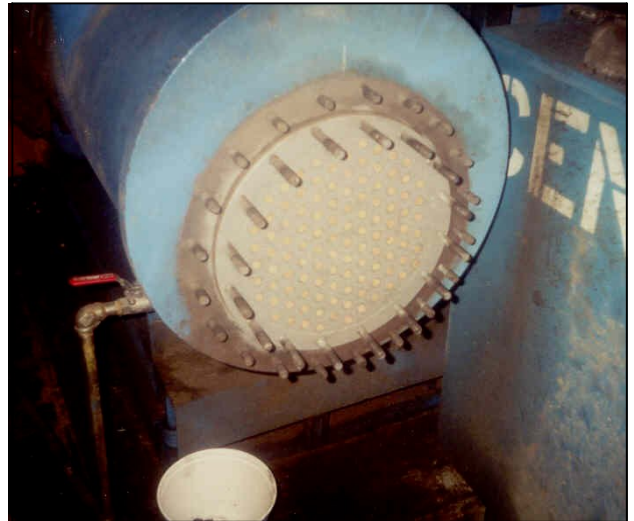
1. Tube sheet face grit blasted with corks in place
2. Tube sheet rebuilt level with protruding tubes and over coated with Belzona 1391 HT Ceramic.
3. Plexiglas placed over repair and secured to ensure an absolute smooth surface once removed.
