## BELZONA® RECLAIMS AND PROTECTS CHEMICAL OFF LOAD AREA

PULP MILL  
Skookumchuck, BC

August 2000

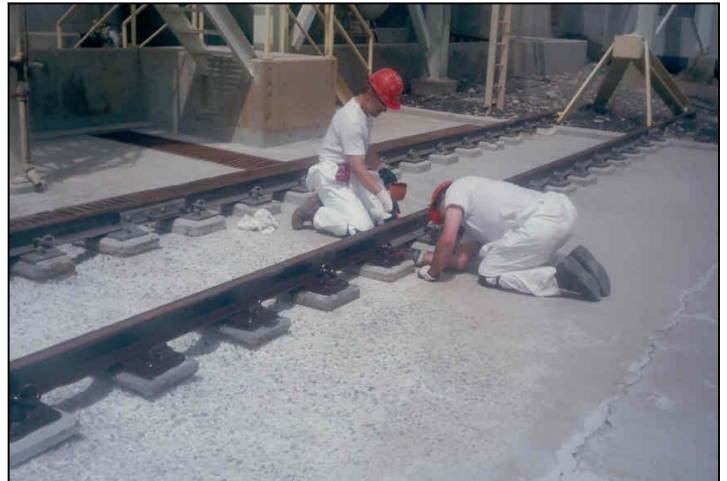
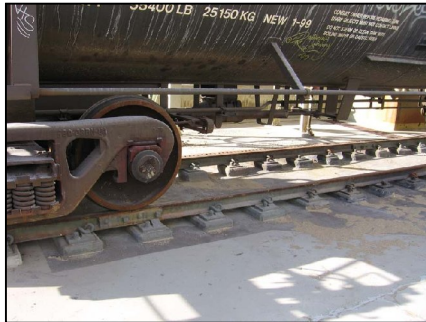
1. View of rail support pads being coated with Belzona 4311 prior to rebuilding the base. *Inset photograph:- Picture shows current condition of the Belzona application taken in February 2006 after 5½ years of service.*
2. Rebuilding the concrete base.
3. Application of Belzona 4311 in progress. This involves two coats (Red/Gray)

Using Belzona® allowed the concrete to be rebuilt and protected against chemical attack without having to jack hammer all the concrete out so that a new off loading pad could be cast. This saved many days of extra downtime.
