BELZONA® REBUILDS DAMAGED GRANITE ROLL

PULP & PAPER MILL
QUEBEC, CANADA

August 2001

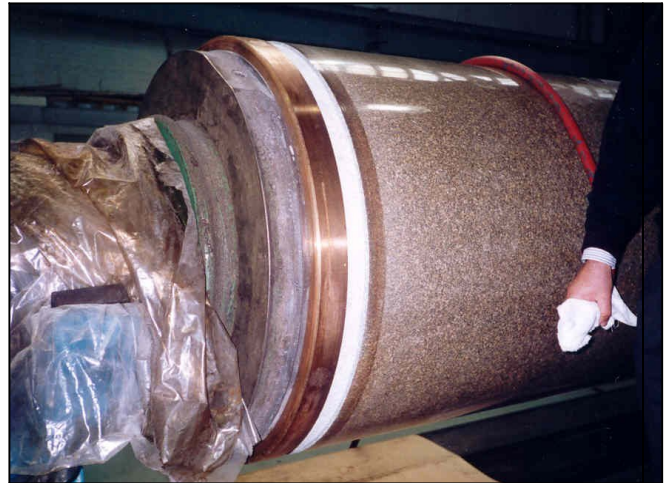
The edge of the granite roll had been damaged causing production problems.

1. View of damaged roll
2. Repair in progress.
3. Completed application before masking tape removed.

This repair was completed using a Belzona quick setting emergency repair compound allowing the repair to be completed in the scheduled 8 hour shut down.
