BELZONA® REBUILDS BRASS PLATED SEAL SURFACE

PULP & PAPER OPERATION
Powell River, BC.

MAY 2000

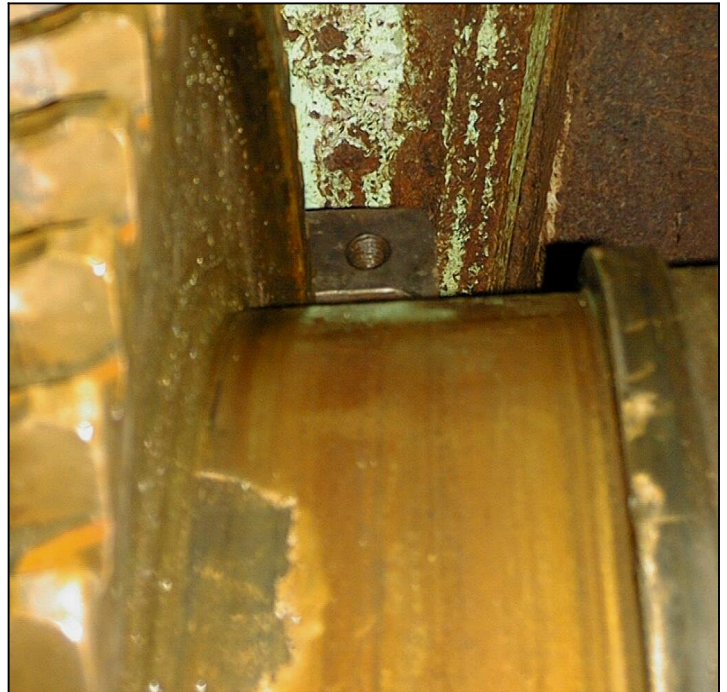
Bronze overlay had started to delaminate from the base metal.

1. View of damage
2. Close up of area after repair

Belzona® 1131 Bearing Metal

Application carried out in accordance with Belzona® Know-How Leaflet MPT-1
