BELZONA® REBUILDS REPULPER SHAFT

PULP & PAPER OPERATION
Port Alberni, BC

September 2000

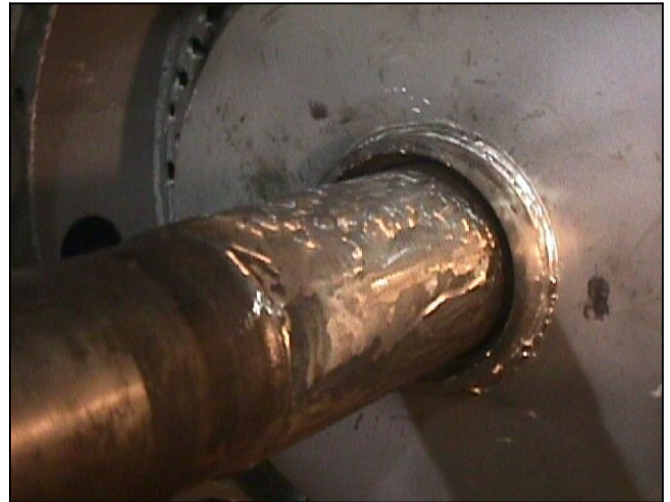
1. View of shaft after it had been roughly ground.
2. Sleeve in position and centered with the grub screws before ends sealed with Belzona® 1221 Super E Metal, a quick setting Belzona® rebuilding compound.
3. Sleeve set in place and Belzona® 1321 injected in through injection ports into gap between the sleeve and worn shaft.

By injecting Belzona® 1321 Ceramic S Metal into the voids the contact area was increased to 100%. This prevented the pulp stock from leaking into the sleeve as it had done on previous occasions and causing the break down. This mill has not had to redo this repair since it went into service 6 years back.
