BELZONA® PROTECTS TMP PRIMARY FEEDER FROM EROSION

PULP & PAPER OPERATION
Powell River, BC.

March 1999

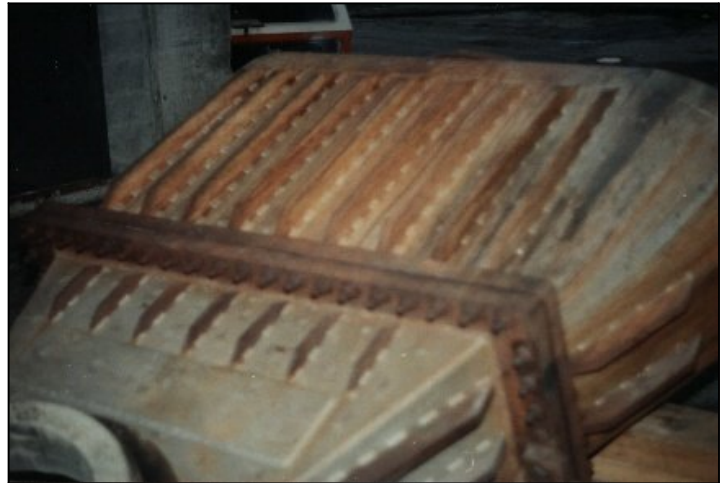
1. View of primary feeder
2. Internal surfaces after grit blasting.
3. Completed application of Belzona® 1591 XHT Ceramic
