BELZONA® IMPROVES CHIP FLOW

PULP & PAPER OPERATION
Powell River, BC.

August 1999

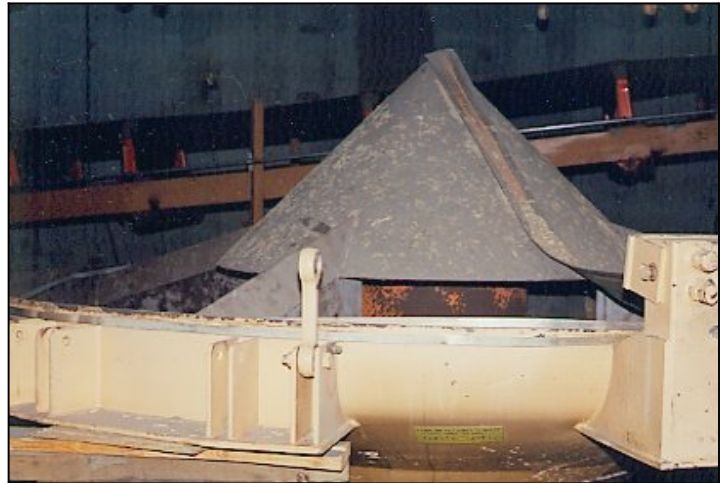
Because of the excessive corrosion chips would not slide evenly over the cone structure of the chip shaker causing it to jam and disrupt the flow.

1. View of corroded cone structure.
2. Application in progress.
3. Application in final stages of completion
