BELZONA® REBUILDS UNDERSIDE OF LOGDECK

PULP PRODUCER
Castlegar, BC

JUNE 2002

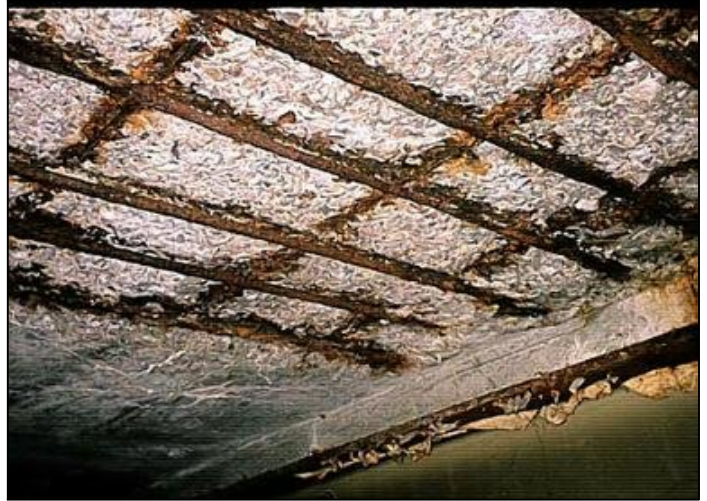
Because of constant impact and moisture penetration from above, corrosion had caused the underside of the concrete deck to spall.

1. View of problem area.
(Inset: Photograph showing condition of application taken March 2006)
2. Repair area after grit blasting to remove all corrosion and loose concrete.
3. Application in final stages of completion.
