BELZONA® 1111 SUPER METAL SAVES COUCH ROLL

PULP AND PAPER
Campbell River, BC.

August 2000

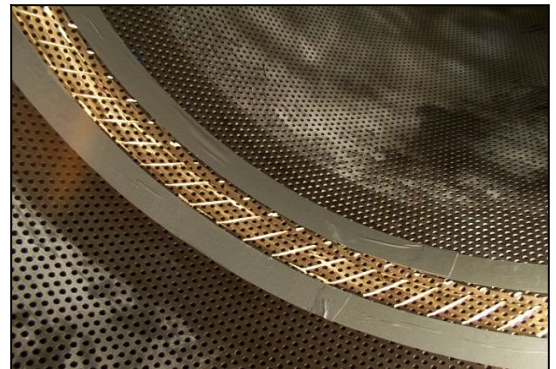
A foreign object had badly damaged the inside of the couch roll.

1. View of damaged couch roll with repair area masked off ready for rebuilding
2. Damaged area rebuilt and plastic forms wedged in place in preparation for drilling.
3. Holes being re-drilled from the outside.
4. View of partially completed area.

The use of the Belzona® repair procedure enabled the mill to repair the damaged area of the couch roll on site in less than 2 days. The alternative would have required shipping the roll to Vancouver incurring tens of thousands of dollars in extra costs for shipping, welding and machining. This repair is still in service 6 years later
