## BELZONA® SAVES DOWNTIME BY REBUILDING WASHER JOURNAL IN PLACE

Pulp & Paper Plant  
Harmac, BC

May 2004

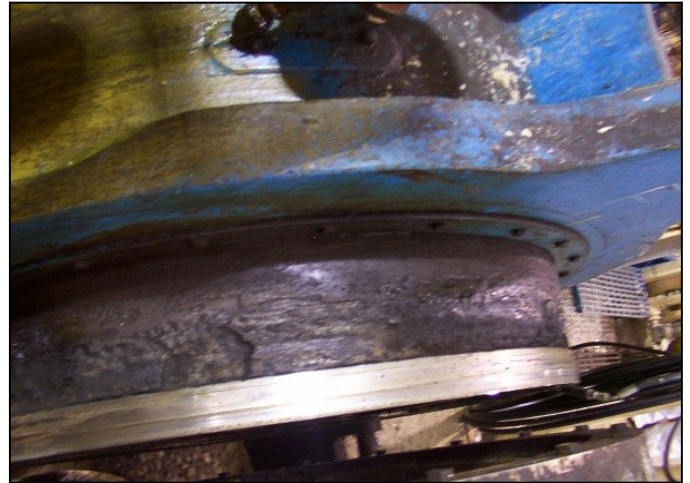
Bearing had seized destroying mounting surface on the dryer journal

1. View of damaged journal surface.
2. Surface of damaged journal ground to a rough profile to ensure good adhesion.
3. The damaged journal surface is molded in place using a prefabricated mold. With the aid of heat lamps this mold was removed within 2 hours to allow reassembly of the component.
