BELZONA® USED TO PROTECT PRECIPITATOR FROM EROSION

Pulp and Paper plant
Vancouver Island, BC

July 2004

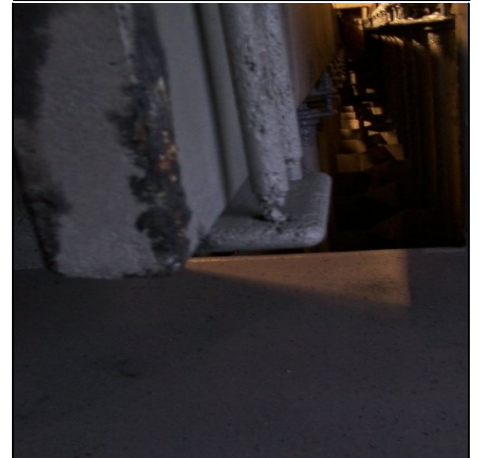
All of the brackets holding the electrodes in place for this Wet Electrostatic Precipitator (WESP) were suffering from massive erosion.

1. Photograph show the extent of the erosion problem. (Inset picture of precipitator plant.
2. View of electrode.
3. Application of Belzona in progress to all the hanging brackets for the electrodes.
4. View of completed application.

Belzona® 1311 Ceramic R Metal
Belzona® 1321 Ceramic S Metal

After a test application pulp mill decided to use Belzona to protect the plant from further degradation. This was a major undertaking with some 200kg of Belzona product applied during the 1st phase of the application.
