## BELZONA® SAVES PUMP FROM THE SCRAP HEAP

Pulp & Paper Plant  
Vancouver Island, BC.

Bearing had failed allowing impeller to drop and gouge out about 0.125ins of metal from the sides of the single stage pump bowl.

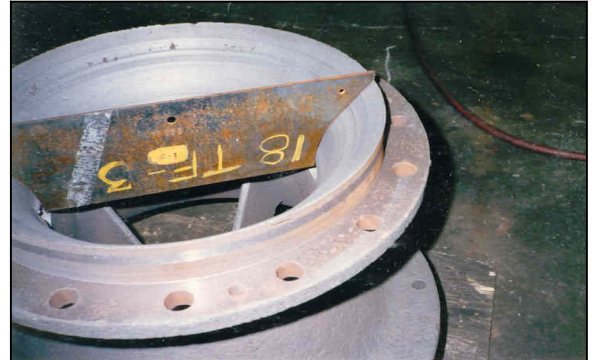
1. Template positioned to show extent of wear around perimeter of the pump bowl.
2. Other deeply imbedded corrosion spots were drilled out to allow for an easier and more positive repair.
3. Belzona® 1111 Super Metal, a paste grade rebuilding material is used to rebuild worn areas. Once cured area was machined to tolerance.
4. After machining 2 coats of Belzona® 1321 Ceramic S Metal were applied for additional protection.
