BELZONA® REBUILDS ERODED VANES OF PUMP BOWL

Pulp & Paper
Vancouver Island, BC

May 1989

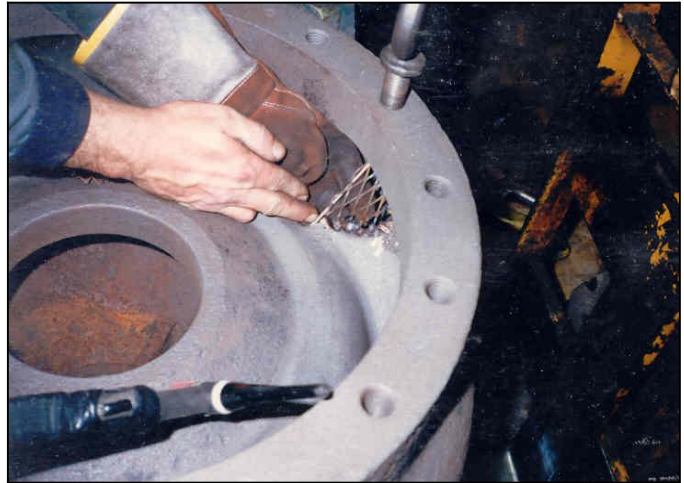
1. Wire reinforcement mesh in the process of being welded onto the eroded vanes to provide additional strength for the rebuild.
2. Tack welding of reinforcement mesh completed.
3. Vanes rebuilt with Belzona® 1321 Ceramic R Metal and over coated with 2 coats of Belzona 1321 Ceramic S Metal for complete protection.
