BELZONA® REBUILDS BEARING SURFACES ON A PAPER MACHINE DRIVE UNIT

Pulp and Paper Company
Port Alberni, BC.

July 2000

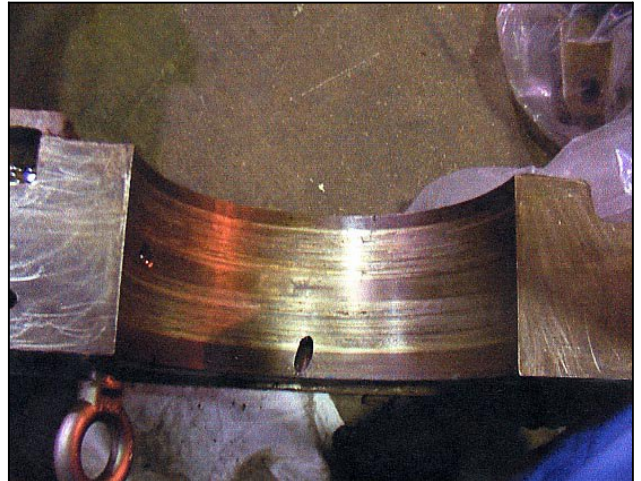
The bearing surfaces of a paper machine main drive unit was badly damaged and starting to cause "gear lash" problems.

1. View of damaged bearing cap.
2. Surface preparation underway.
3. Completed repair
