BELZONA® REBUILDS BEARING FIT ON PAPER MACHINE DRIVE

Pulp & Paper
Port Alberni, BC.

Worn bearing fit causing gear lash problems.

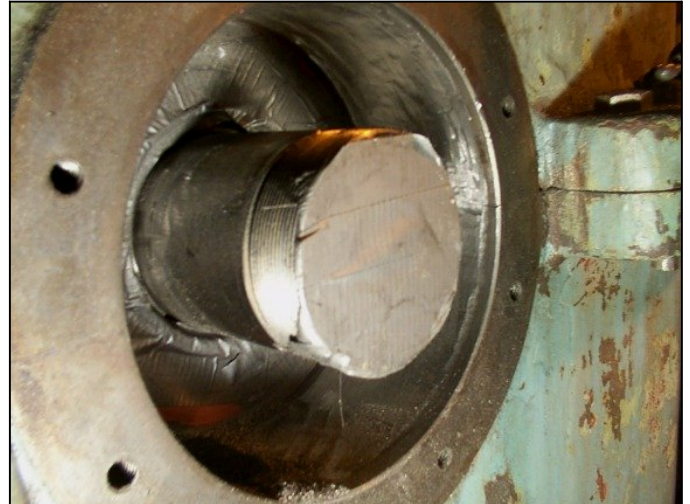
1. Fit area has been ground out with a die grinder.
2. Mold was shrunk with nitrogen to ensure easy fit without damaging release agent when put in place. It is still warming up at this point.
3. Finished bearing fit, another absolutely perfect fit, done in less time than it would have taken to disassemble the housing.
