BELZONA® PROTECTS CHEMICAL CONTAINMENT AREA

Pulp & Paper Facility
Port Alberni, BC.

DATE June 2005

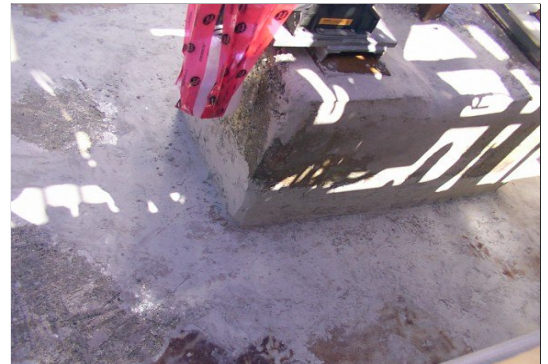
1. Pump plinths rebuilt and areas of the floor resurfaced where necessary with Belzona® 4141 Magma Build.
2. Application of 1st coat of Belzona® 4311 Magma CR Barrier (Red)
3. Application of 2nd coat of Belzona® 4311 Magma CR Barrier (Grey)
4. Walls above the 6 inch line were protected with 2 coats of Belzona® 5811 Immersion Grade.
