## **BELZONA® 4000 SERIES PRODUCTS REBUILD REINFORCED CONCRETE WALL**

Pulp and Paper Operation  
Castlegar, BC

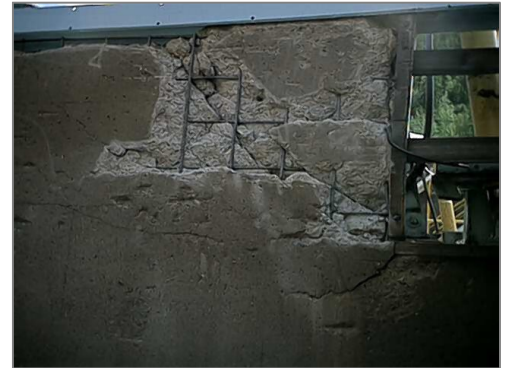
1. A suitably sized steel channel was placed over the top edge of the wall to help anchor the broken sections in place. *INSET PHOTOGRAPH: Shows condition of repair in May 2006*
2. The damaged sections were then rebuild and "glued" into place with Belzona 4111 and 4141
3. Another section of the damaged wall showing reinforcing channel in place.
4. View of repaired wall taken 2 years later in May 2006, showing how well the repair has stood up against the constant impact of loaded chip buckets being constantly driven into it.

Application carried out in accordance with a modified version of Belzona® Know-How Leaflet FPA-1

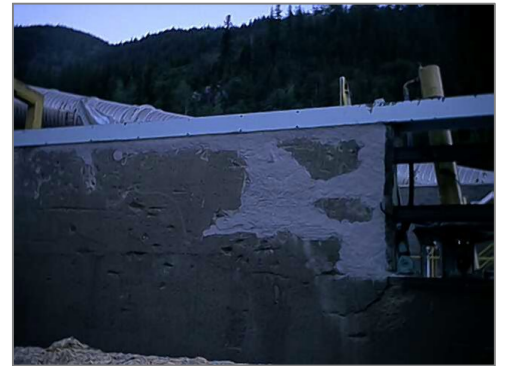
The reinforced concrete wall had been damaged by heavy duty front end loaders equipped with large chip loading buckets
