BELZONA® 1812 USED TO REBUILD AND PROTECT ID FAN HOUSING FROM EROSION

Pulp & Paper Operation
Port Alberni, BC

June 2002

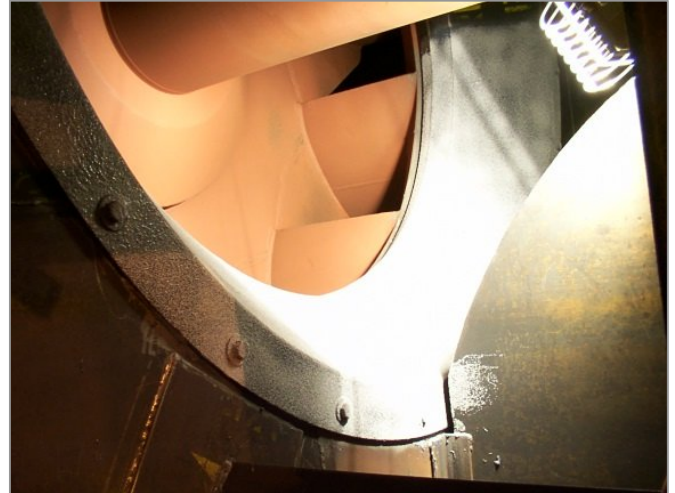
1. Unit prior to surface preparation
2. Preparation of the metal surfaces was by grit blasting.
3. Completed application of Belzona 1812 Ceramic Carbide FP.

Rebuilding and protecting from further abrasion without having to dismantle resulted in saving a significant amount of downtime. This unit had suffered a major amount of metal loss when checked for thickness. Rebuilding with Belzona 1812 allowed unit to operate for another year before being replaced. When it was replaced in 2003 it was established that the housing had suffered no further metal loss. *This result lead the mill to have the replacement units pre-coated prior to installation. See BC KHIA #174*
