BELZONA® REBUILDS CAST IRON PUMP BOWL

OEM PUMP MANUFACTURER
Burnaby, BC

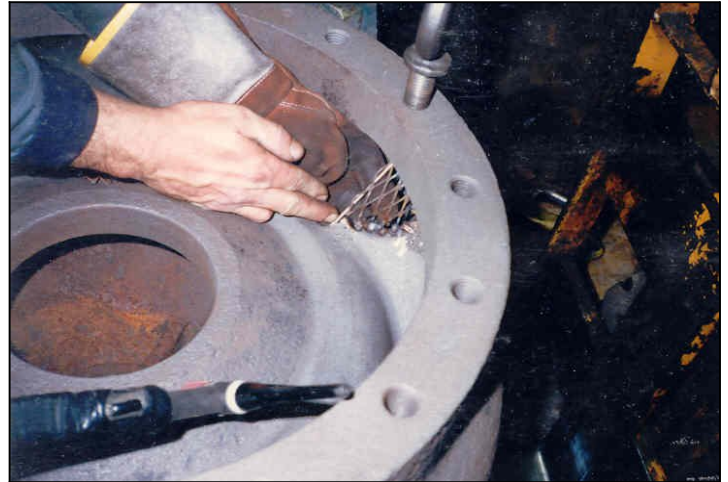
Bi-metallic corrosion had eroded much of the metal vanes rendering pump ineffective.

1. View of pump bowl with vanes under construction.
2. Reinforcement frame work for vanes completed.
3. Vanes rebuilt and entire bowl protected from further erosion corrosion.

Belzona® 1311 Ceramic R Metal
Belzona® 1321 Ceramic S Metal

Application carried out in accordance with Belzona® Know-How Leaflets CEP-1,5
