## BELZONA® SAVES & PROTECTS VACUUM

PULP & PAPER OPERATION  
Nanaimo, BC

Massive erosion of metal had rendered vacuum pump ineffective.

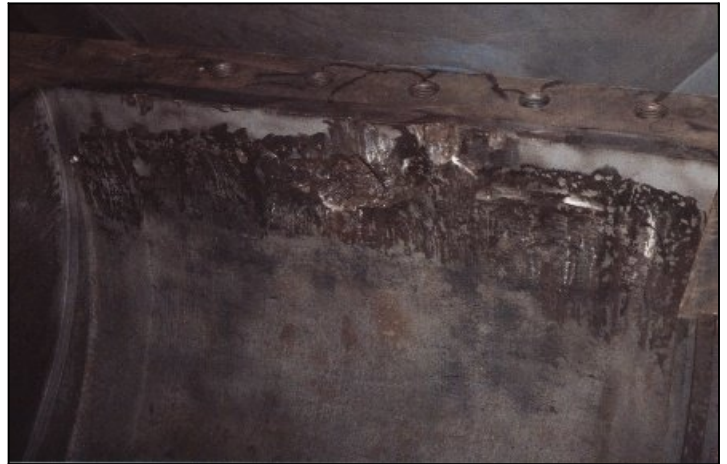
1. View of eroded casing
2. Close up showing extent of metal loss.
3. Completed application

Rebuilding with Belzona® allowed the vacuum pump to be repaired in house saving both downtime and maintenance dollars. The unit was also protected internally to prevent the problem from re-occurring.
