BELZONA® SAVES BRINE PUMP FROM THE SCRAP HEAP

RECREATION CENTER – HOCKEY RINK
British Columbia, Canada

Pump used to pump brine solution was slated for the scrap heap

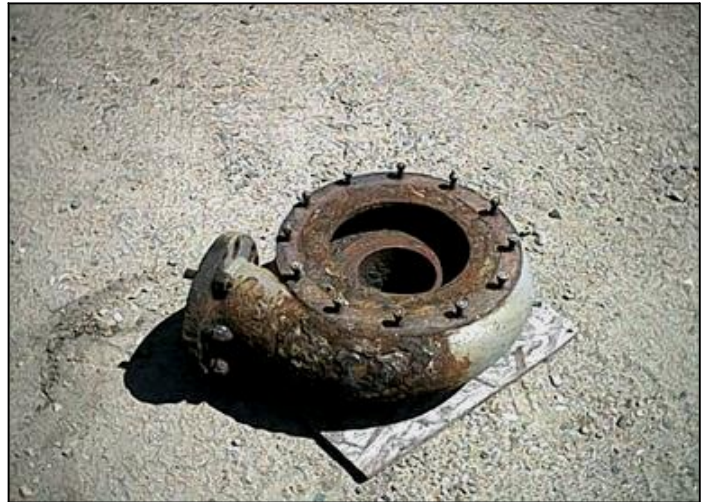
1. View of corroded pump body
2. Completed application with inside repaired and coated with Belzona® 1321 and the outside protected with Belzona® 5811 Immersion Grade
