## BELZONA® REBUILDS VACUUM PUMP CASING

Pulp & Paper Company  
Nanaimo, BC

September 2001

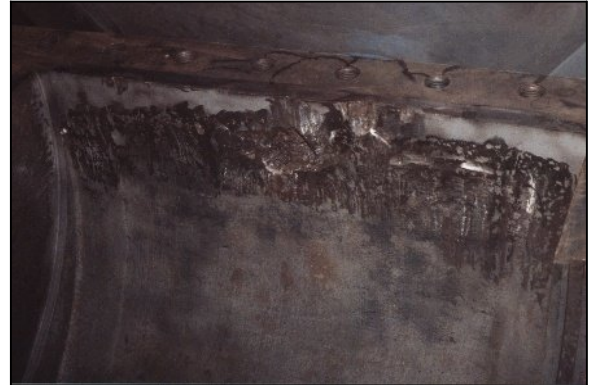
The vacuum pump housing had become badly eroded decreasing the units efficiency.

1. View of damaged vacuum pump casing.
2. Application of Belzona® 1311 Ceramic R Metal in progress with flange area still to be rebuilt.
3. Application of 1<sup>st</sup> coat of Belzona® 1321 Ceramic S Metal (Blue)
4. Application of 2<sup>nd</sup> coat of Belzona® 1321 Ceramic S Metal (Grey)
