## BELZONA® PUMP SPLITTER REBUILD

Mining Company  
Tumbler Ridge, BC

Cast iron pump splitter had broken away.

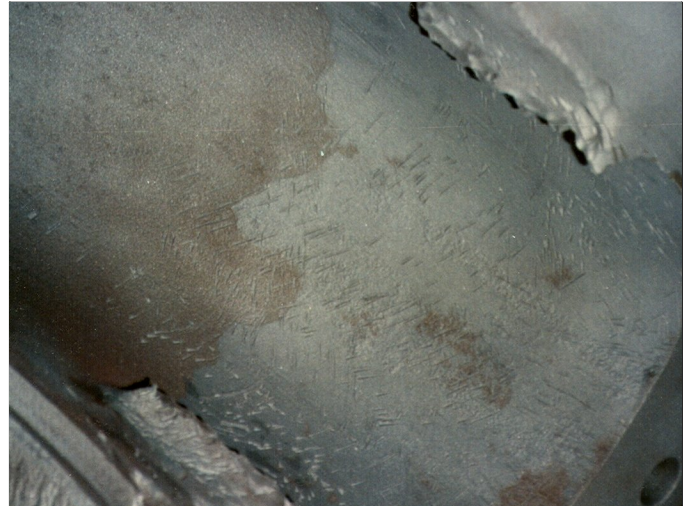
1. View of missing splitter.
2. Reinforcement in place for construction of new fabricated splitter using Belzona 1311 Ceramic R Metal.
3. Rebuilt splitter.
