BELZONA® REBUILDS ERODED PUMP DIFFUSER

Wastewater Treatment Facility
Abbotsford, BC.

October 2005

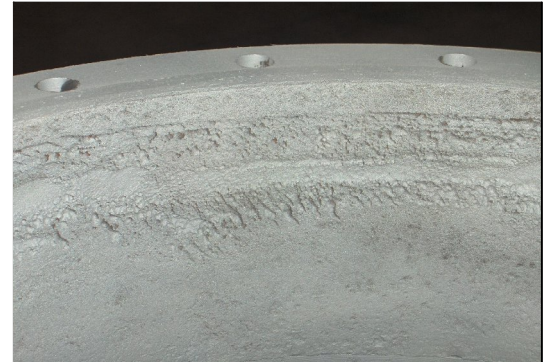
1. Eroded area after grit blasting.
2. Application of 1st coat Belzona® 1321 to ensure that all eroded areas are completely coated before rebuilding.
3. Eroded area rebuilt and filled with Belzona® 1311 Ceramic R Metal
4. View of completed application with 2nd Coat of Belzona 1321® Ceramic S Metal applied.
