## BELZONA® PERFORMANCE IMPROVEMENT PROGRAM (PIP) CUTS RUNNING COSTS DRAMATICALLY

Submersible potable water booster pump

Reduced flow and pressure coupled with motor overheating

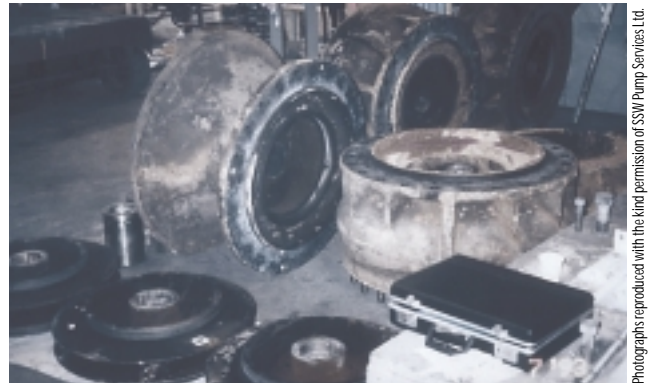
The pump unit was identified for potential overhaul while still in service due to reduced output and overheating of the drive motor, a characteristic of reduced hydraulic performance. When the unit was removed and disassembled for inspection, considerable erosion had occurred on the diffuser bowls, which were also badly deteriorated from the effects of nodal growth and corrosion. By utilizing Belzona computer generated overhaul techniques specific to this pump type and its operating conditions, substantial savings in running costs - approximately \$55,000/year, coupled with sustained high levels of performance, increased output and long term protection were achieved.

1. Deteriorated pump components
2. Performance improvement information
3. The completed application following refurbishment
