## BELZONA® SEALS GAP BETWEEN WALL AND ACCESS RAMP

CITY OF BURNABY  
Recreation Center

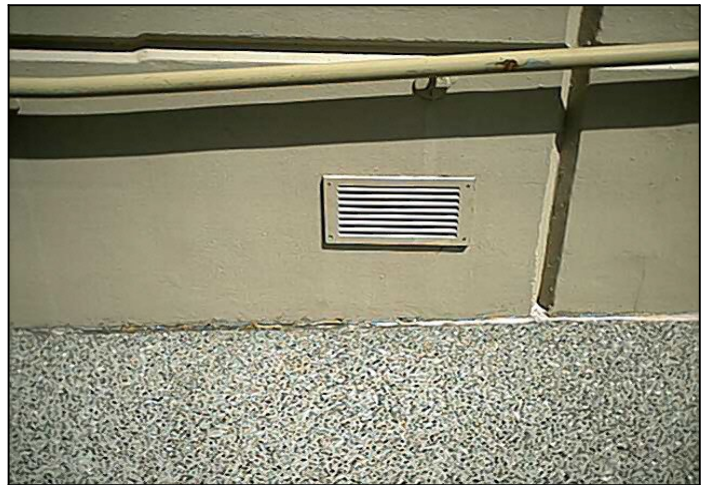
1. View of joint to be sealed
2. Application of 1<sup>st</sup> coat of Belzona 3111 Flexible Membrane in progress along with reinforcement sheet.
3. Completed application

Belzona® 3111 Flexible Membrane was used to create a flexible flashing between the wall and floor.
