BELZONA® 3111 PROTECTS STAIRCASE FROM CORROSION

RECREATION CENTER
Trail, BC.

June 2003

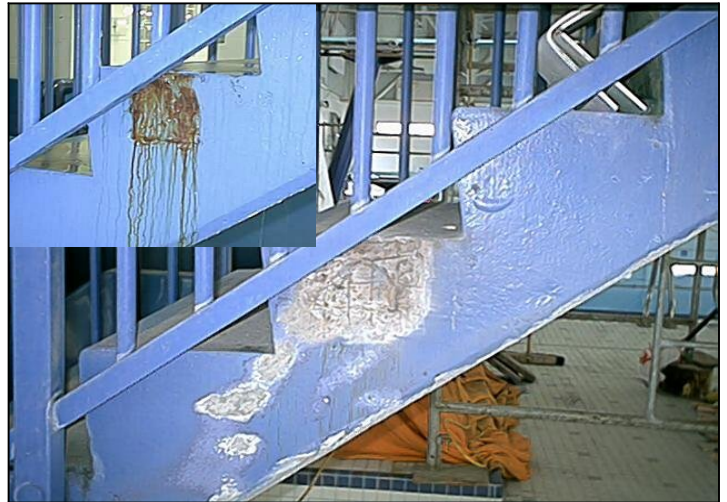
The wrought iron stair rail was a constant source of unsightly corrosion leading to unsightly staining. Additionally the underside coating required repainting every year.

1. View of structure showing the corrosion problem
2. Surface preparation via wet sand blasting in progress.
3. Completed application
