BELZONA® REDUCES COST OF EXPANSION JOINT REFURBISHMENT

Public Recreation Facility
Burnaby, BC

March 1996

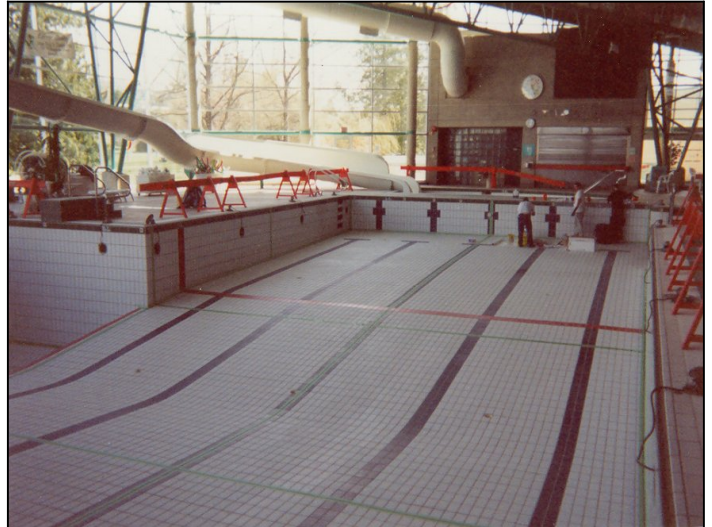
1. General view of facility
2. View of the hot tub
3. View of completed expansion joints.

After the installation of the Belzona® Elastomers annual refurbishment of expansion joints was eliminated. In the harshest area –hot tub – the Belzona® product lasted 4 years. Other areas have lasted 7 years without the need for additional maintenance saving the facility time and maintenance dollars.
