BELZONA® REDUCES COST OF EXPANSION JOINT REFURBISHMENT

Public Recreation Facility
Williams Lake, BC

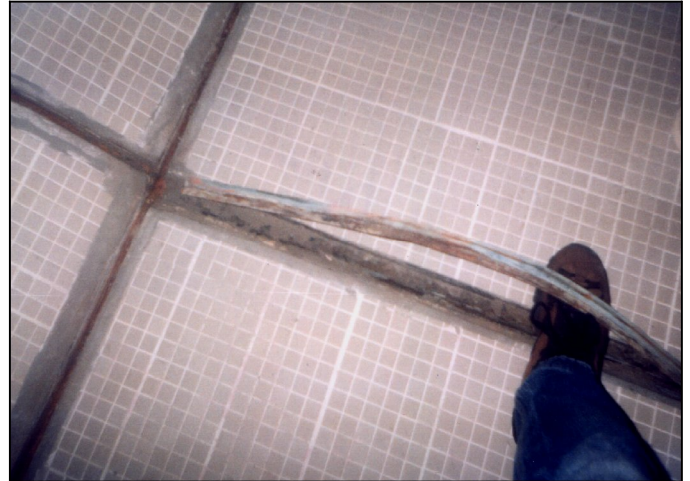
Deterioration of expansion joints were a constant problem. This facility would budget annually for the replacement of expansion joint material. This repetitive repair and refurbishment work was creating a constant drain on the annual maintenance budget.

1. General view of deteriorated expansion joint
2. Application in progress
3. View of completed expansion joint section.

After the installation of the Belzona® Elastomers annual refurbishment of the expansion joints was eliminated. These joints are now 7 years old and still providing protection to the joints.
