## **BELZONA® REDUCES COST OF EXPANSION JOINT REFURBISHMENT**

Aquatic Center  
Trail, BC

1998

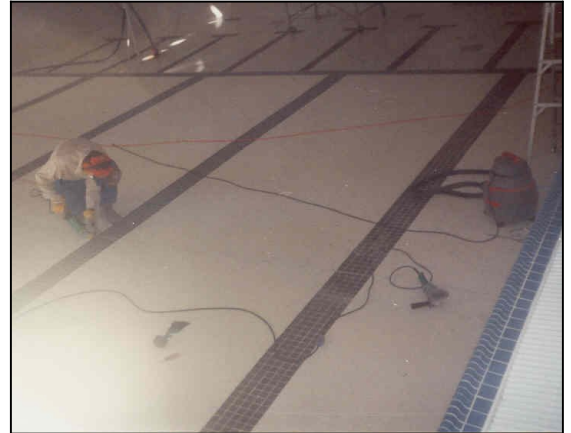
1. Preparation of joints prior to application of Belzona 2000 Series Elastomers.
2. Application in progress on one of the vertical joints.
3. View of completed expansion joint section.
