BELZONA® REBUILD AND PROTECTS SPALLED CONCRETE STAIRS

Municipal Recreation Center
Burnaby, BC.

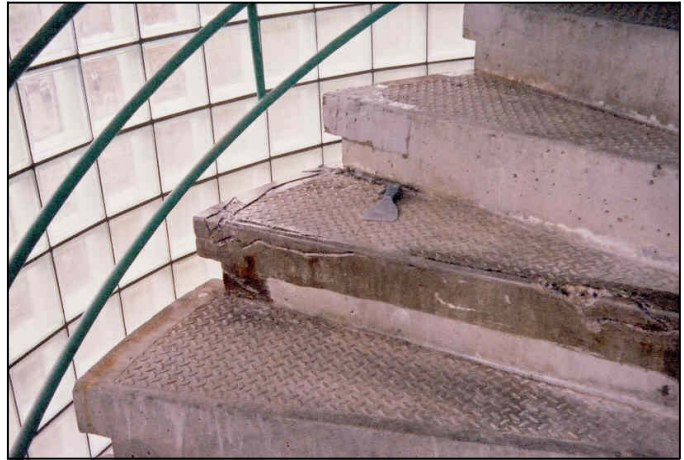
1. Preparation in progress
2. Surfaces coated with Belzona® 4911 TX Conditioner
3. Completed repairs with front of stairs refaced. With minimal repairs over the next few years a decision was made to reface all the stairs with Belzona® 4131 to improve the visual aspects of the stairs.

The Belzona product was able to repair and seal all cracks as well as resurface the spalled areas. After completion the whole area was protected with Belzona® 5122 Clear Cladding to impede further water ingress.
