BELZONA® RESURFACES CONCRETE AT ENTRANCE TO ICE RINK

Ice Arena
Williams Lake, BC

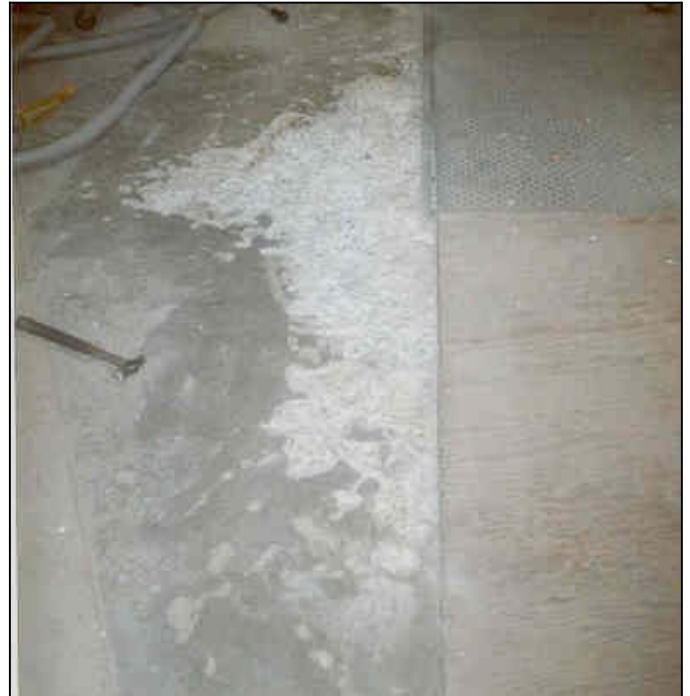
Concrete at the entrance to the ice rink had become badly spalled making it difficult for the Zamboni to get on and off the ice sheet.

1. View of damaged area.
2. Completed application

Belzona® 4111 Magma Quartz

Application carried out in accordance with Belzona® Know-How Leaflet FPA-1

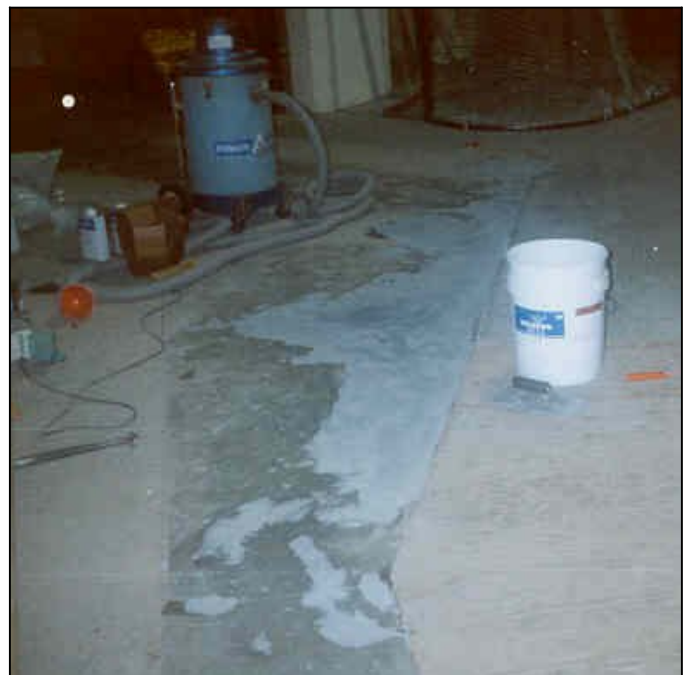
Because of temperature variations all products previously used had failed within a year. This repair is still in service some 5 years later.
