BELZONA® REBUILDS CORRODED STEEL DOOR FRAMES

Recreation Facility
Qualicum Beach, BC

August 2004

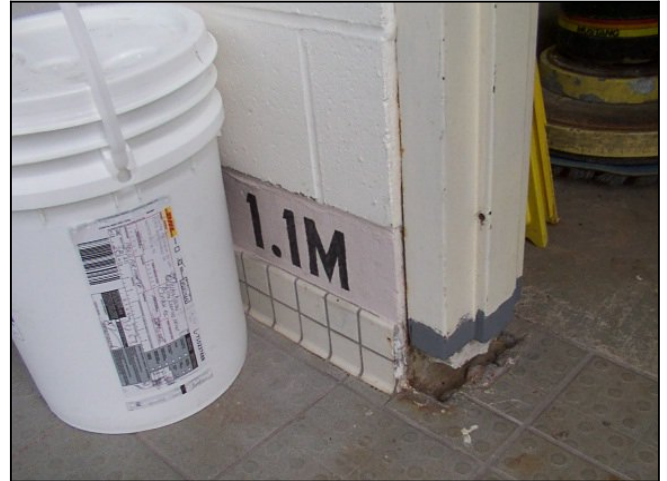
Bottoms of steel door frames had corroded away as a result of constantly being in contact with pool water.

1. View of one of the many corroded door frames with the bottom section cut away.
2. Bottom section rebuilt with Belzona® 4141 Magma Build
3. Repaired area repainted white.
