BELZONA® PROVIDES A WATER TIGHT SEAL FOR SWIMMING POOL

University of Victoria

September 2004

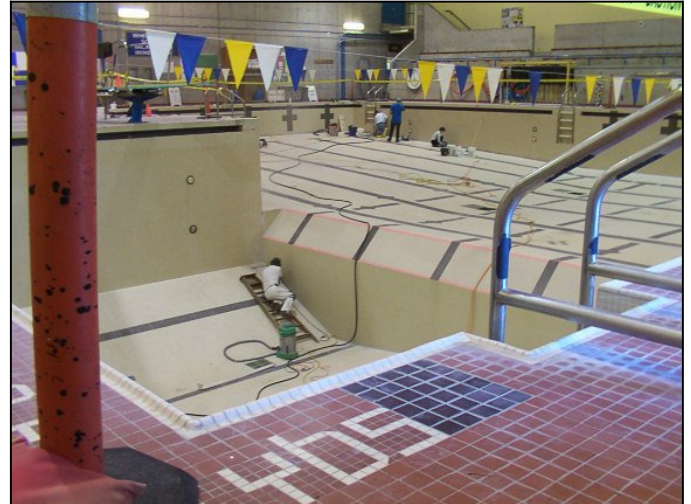
1. Removal of old expansion joint material underway. The joints on this pool were tiled over which necessitated their removal to expose the joint
2. View of prepared joint
3. Application of Belzona 2221 MP Fluid Elastomer in progress. Once expansion joints had been rebuilt the area was retiled.

The swimming pool was losing water at an alarming rate. An inspection revealed that the expansion seal joints around the perimeter of the pool had failed.
