BELZONA® RESURFACES LEAKING POOL SUMP

University Swimming Pool
Victoria, BC

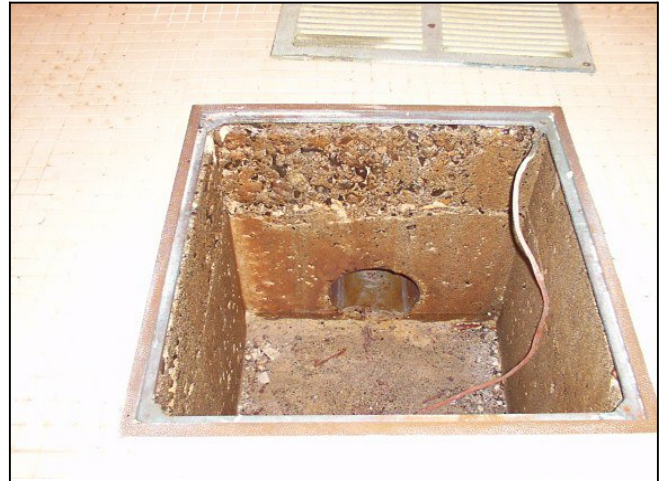
This was one of the many points from which the pool was losing water

1. View of the degraded concrete sump.
2. View of one of the worst areas of sump
3. Resurfaced sump

The use of Belzona® allowed the sides and bottom of the drain to be resurfaced. The non-porous nature of the product ensured a water tight solution.
