BELZONA® REBUILDS POOL UNDERWATER WINDOWS

Aquatic and Recreation Center
Nelson, BC

November 2004

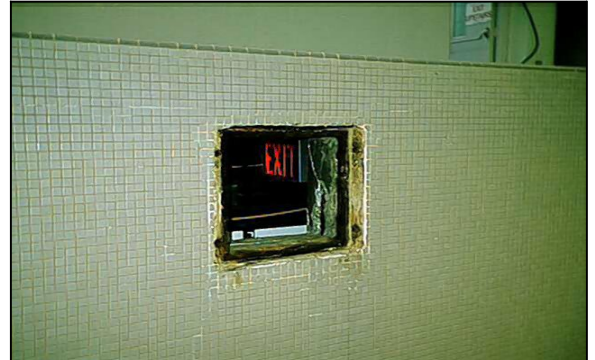
The original windows openings were framed in steel and had corroded badly over the years.

1. The window opening with the Plexiglas removed showing the corroded steel frame in the back ground.
2. Preparation of the opening complete with all the corroded steel work removed.
3. The original Plexiglas window with various modifications was used as a mold for the new opening. Note the hinged lever system used to hold the mold in place.
4. Completed application. This is only the 1st phase of the application. Final phase is the use of Belzona® 2211 to bond the new 1 inch thick Plexiglas windows into the opening
