BELZONA® REBUILDS POOL UNDER WATER WINDOWS

Recreation Center
Nelson, BC.

January 2005

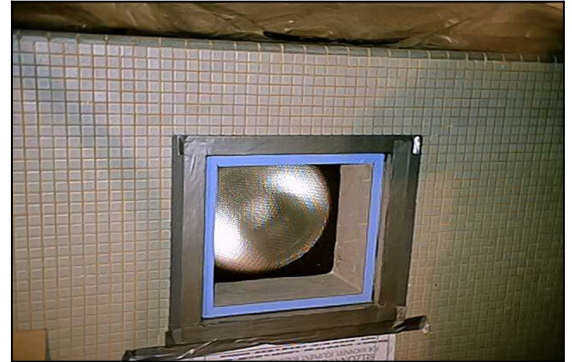
1. The aperture was masked off and a special double sided adhesive glazing tape was applied to back surface of the aperture. This allowed the new Plexiglas to be accurately positioned against it in readiness for the application of Belzona® 2211 MP Hi-Build Elastomer.
(Inset shows one of the 26 rebuilt apertures – see BC KHIA # 192)
2. Plexiglas sheet showing edge detailing. A groove $\frac{1}{2}$ " x $\frac{1}{4}$ " was cut into the edge of the Plexiglas which was 1 inch thick.
3. Once the Plexiglas was in place, Belzona® 2211 MP Hi-Build Elastomer was injected into the gap between the wall and glass to provide a seal from the inside of the pool.
4. Completed application.
