BELZONA® EXTENDS THE LIFE OF SWIMMING POOL FILTER POTS

Recreation Center
Grand Forks, BC.

The cast mild steel filter pots had corroded through in various places.

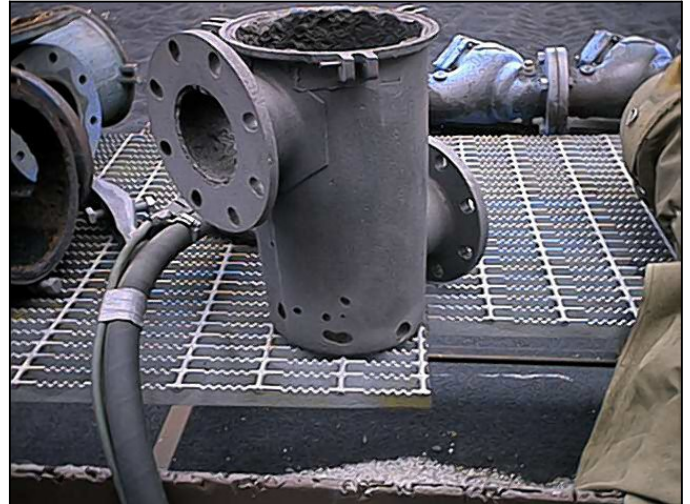
1. Condition of unit after blasting showing holes in bottom.
2. Eroded sealing flange.
3. Rebuilt unit coated with Belzona® 1321 on the inside and Belzona® 5811 on the outside. The holes were covered over with suitable metal plates before being encapsulated, while the flange face was rebuilt to accept a new flat type rubber seal for better sealing characteristics.
