BELZONA® 4000 SERIES PRODUCTS REFURBISH RED TILES

Recreation Center
Burnaby, BC

March 2005

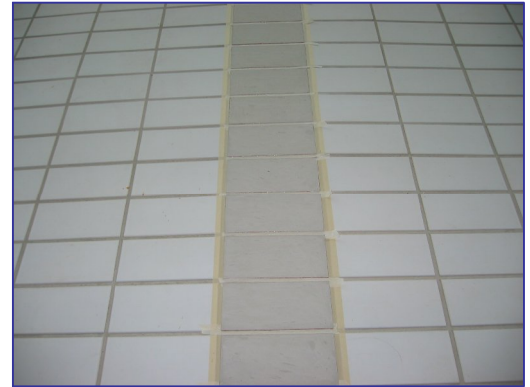
1. The original red glazing was scraped off before the tile surfaces were ground to provide a smooth porous surface.
2. The ground surfaces were first conditioned with Belzona 4911 TX Conditioner.
3. Application of 1st coat of Belzona 4411 Granogrip (Red).
4. Completed application
