BELZONA® 4411 GRANOGRIP USED TO REPLACE FADED POOL MARKINGS

Recreation Center
Burnaby, BC

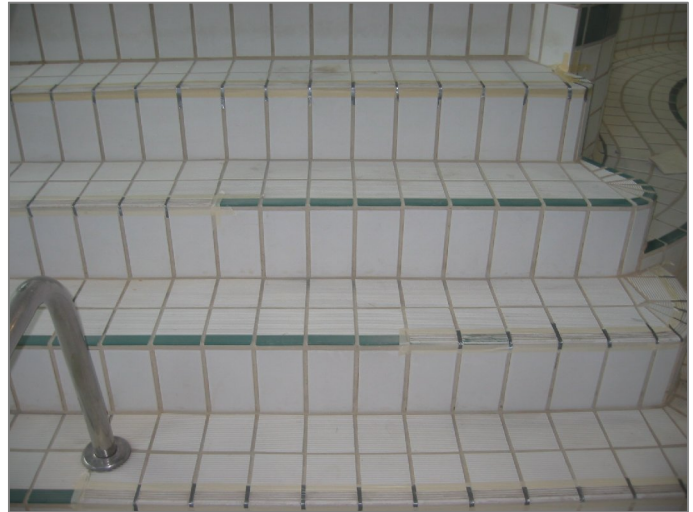
1. The strip along the edge of the tile was ground to expose a porous surface and masked off to ensure a neat finish.
2. Application in progress.
3. Completed application.
