BELZONA® MEMBRANE PROTECTS COLUMNS FROM CORROSION

Recreation Center
Burnaby, BC.

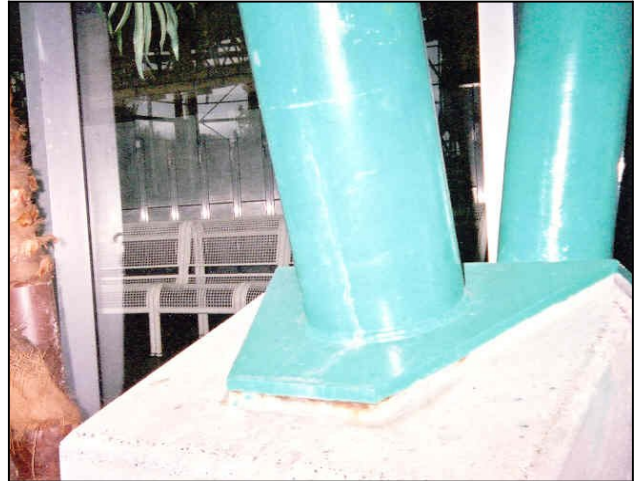
Because of the constant dampness and high humidity corrosion between the mild steel base plates and the concrete plinths was a perennial problem.

1. View of corrosion problem
2. Application of Belzona® 3111 Flexible Membrane in progress.
3. Completed application
