BELZONA® 1341 PROTECTS PUMP COMPONENTS

Recreation Center
Qualicum Beach, BC

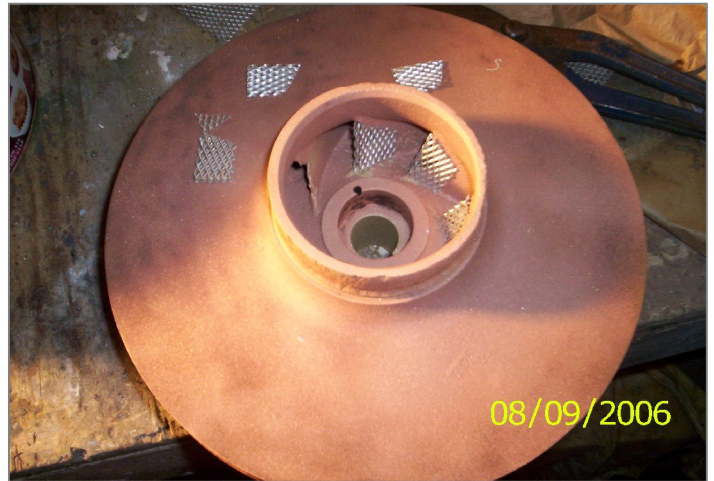
1. Impeller showing eroded vanes in the process of being rebuilt with a fine expanded mesh.
2. The vanes rebuilt with Belzona 1311 Ceramic R Metal
3. The impellers protected from future erosion using Belzona 1341 Supermetalgilde.
