BELZONA® 3000 SERIES PRODUCTS SOLVE CORROSION PROBLEM

Swimming Pool
Trail, BC

May 2006

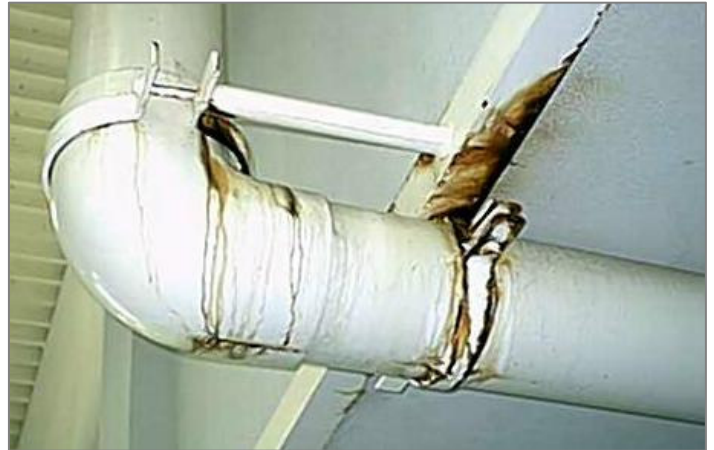
Condensation was settling on various parts of the pipe hanger brackets causing them to corrode and thus creating an unsightly visual problem as well as leaving rust stains on the floor area beneath them .

1. View of one of the problem areas
2. Preparation of the area underway.
3. Completed application

Sealing the hanger brackets in this way prevents water from getting underneath the metal hangers and stops the corrosion problem.
